9600 Natural Bridge Road Blighted Area Qualifications Study

January 9, 2025

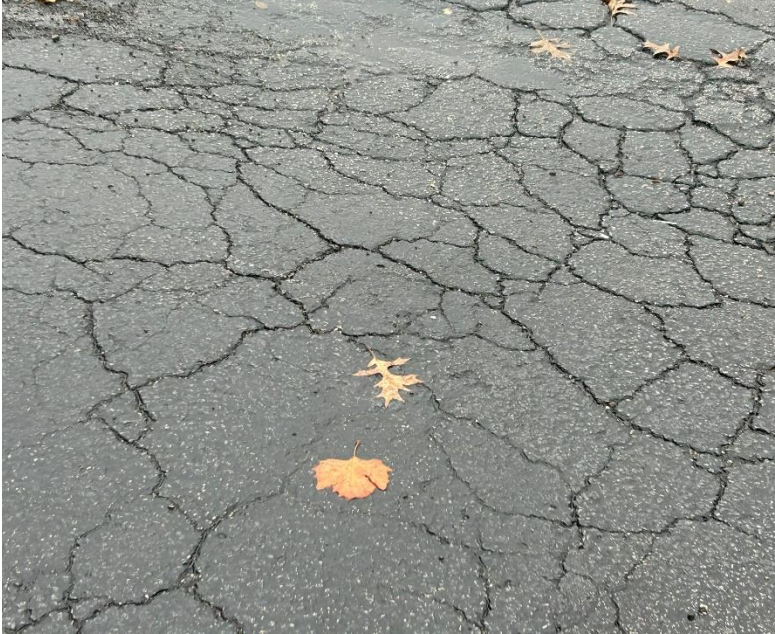
1

- The asphalt parking lot surfaces within the Area show signs of “alligator cracking,” which is a condition of widespread cracks across the surface and which indicate the top surface and subsurface have both lost structural integrity and require replacement.

Above and below: Deteriorated asphalt pavement.

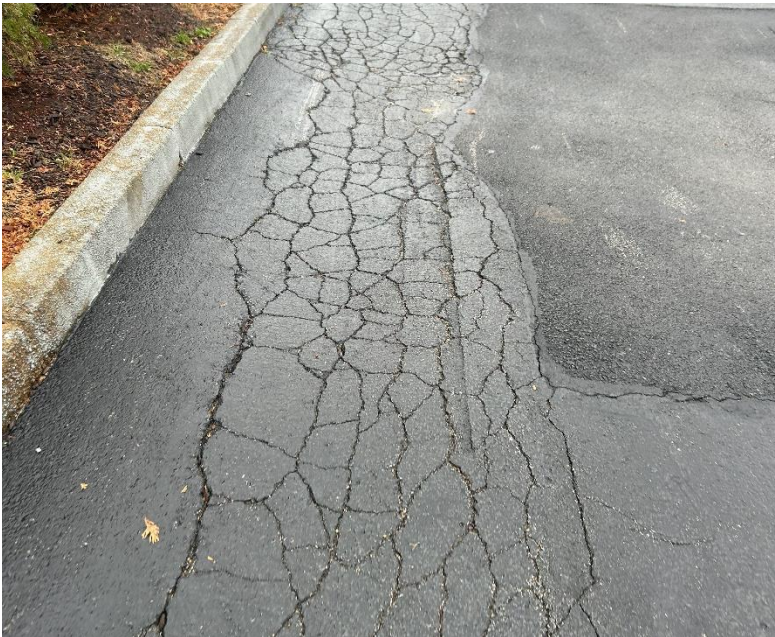
2

Above: Deteriorated runway.

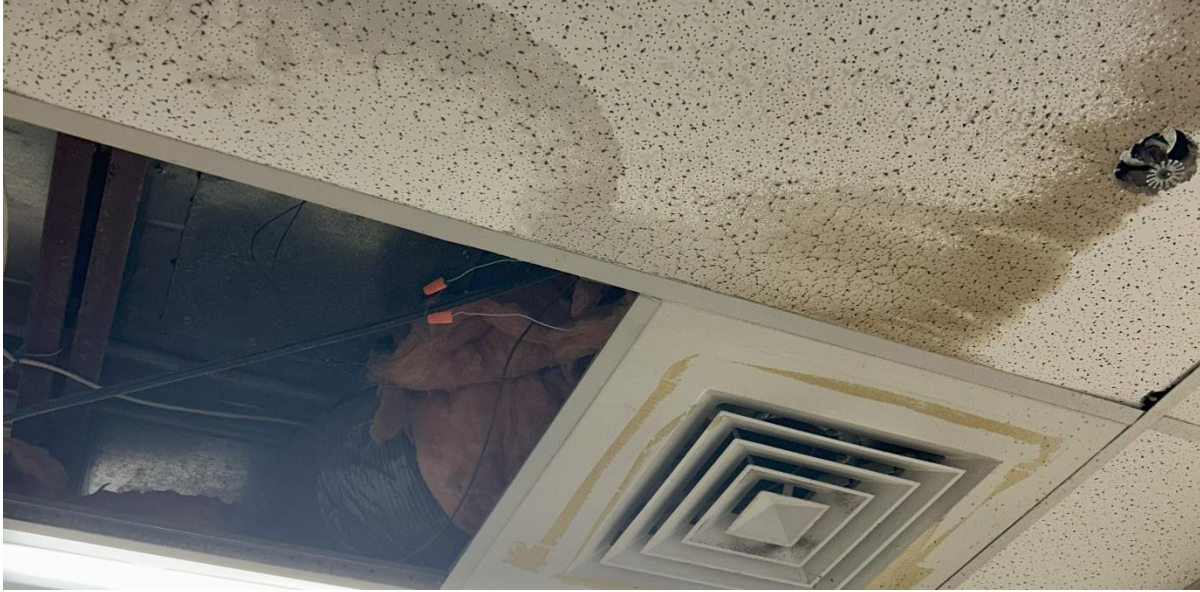
3

Above: Water damage in the interior of the Hotel.

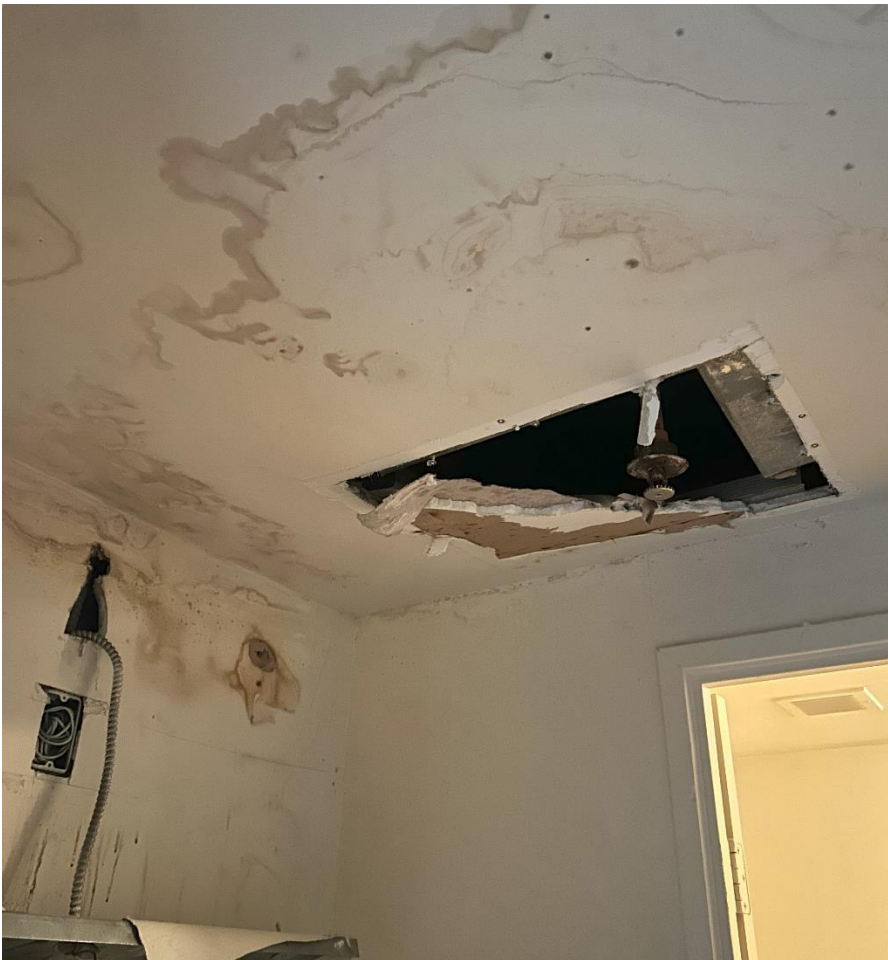
4

Mold growth is present as a result of water damage due to deferred maintenance and the deterioration of building components and presents a health hazard.

Above: Water damage and mold in the interior of the Hotel.

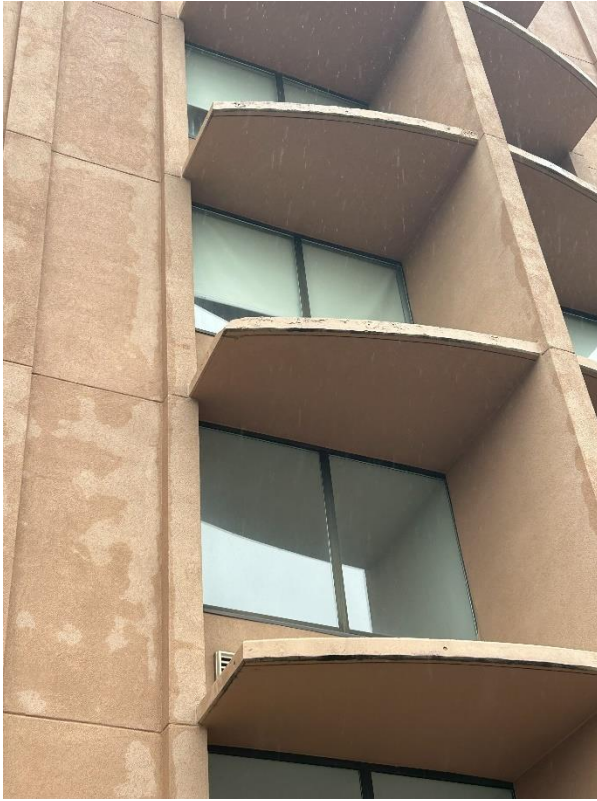
5

Left: Deteriorated Hotel exterior. These platforms were once used as balconies but now serve no functional purpose.

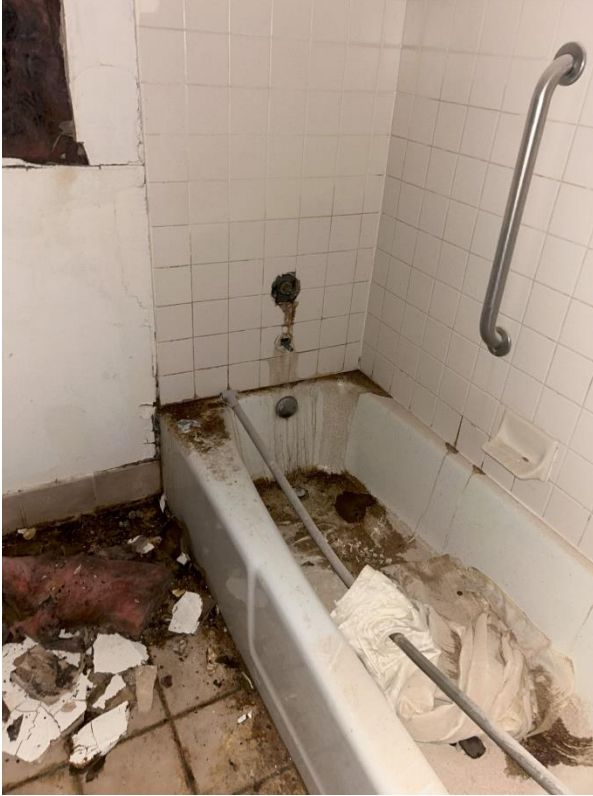
6

Left: Inhabitable hotel room.

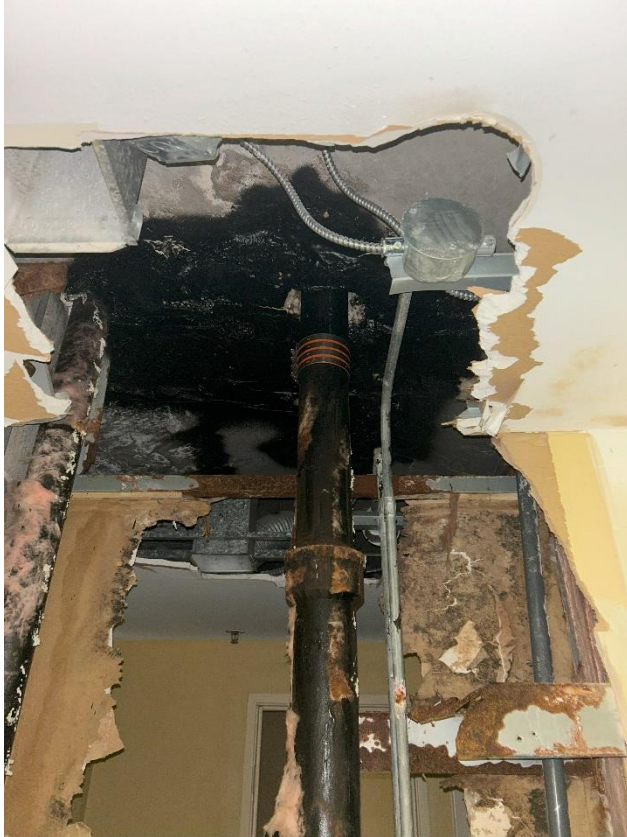
7

Left: Evidence of interior hotel room water damage.

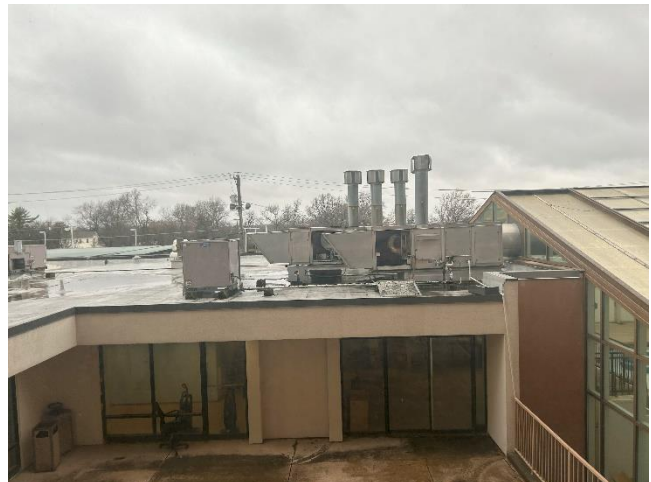
8

Right: An image of the inoperable air handles associated with the pool building.

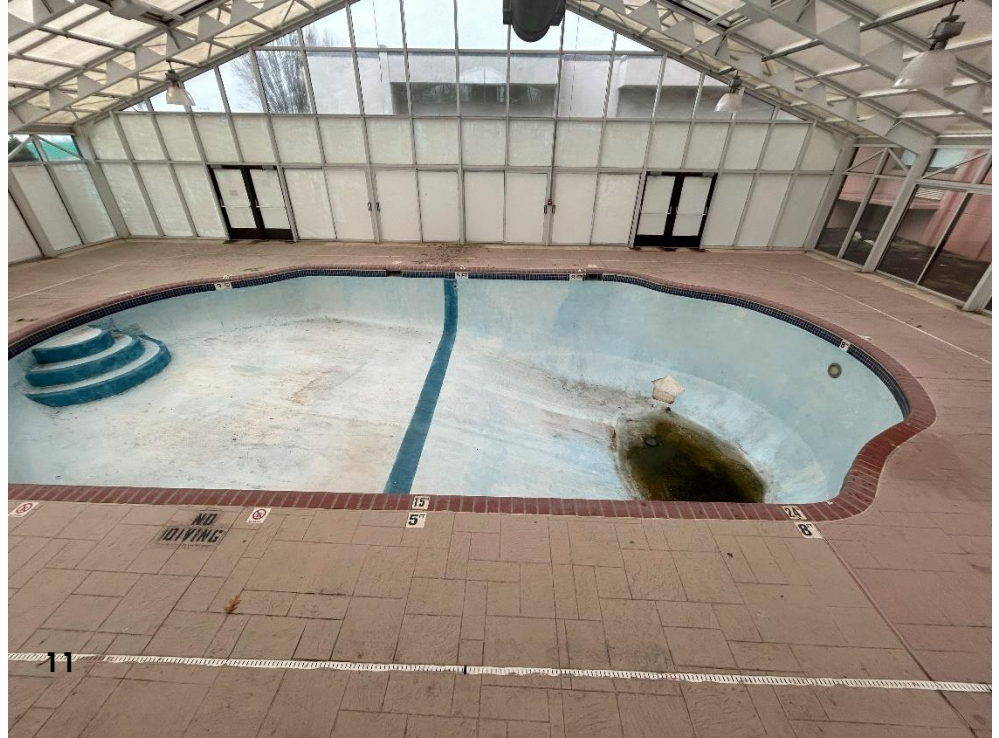
9

Right: Image of moldy, disused, deteriorated pool and building.
